**PROTECTO ENGINEERING PRIVATE LIMITED**

**STAGES IN SERVICING OF PUMPSET.**

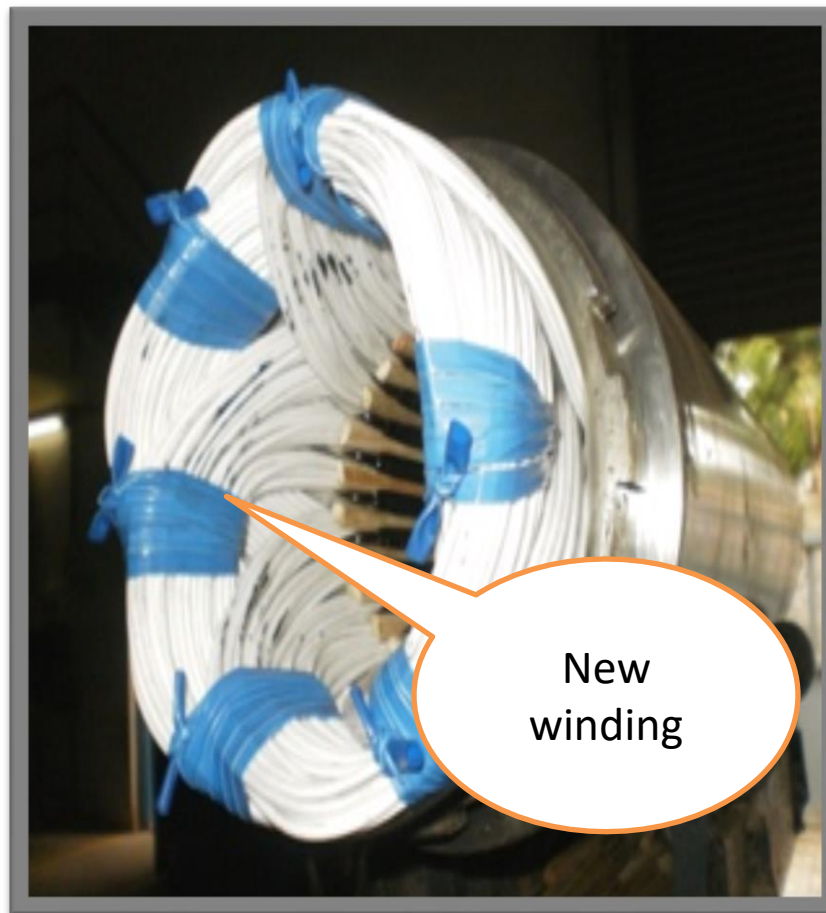
## AFTER

New  
winding

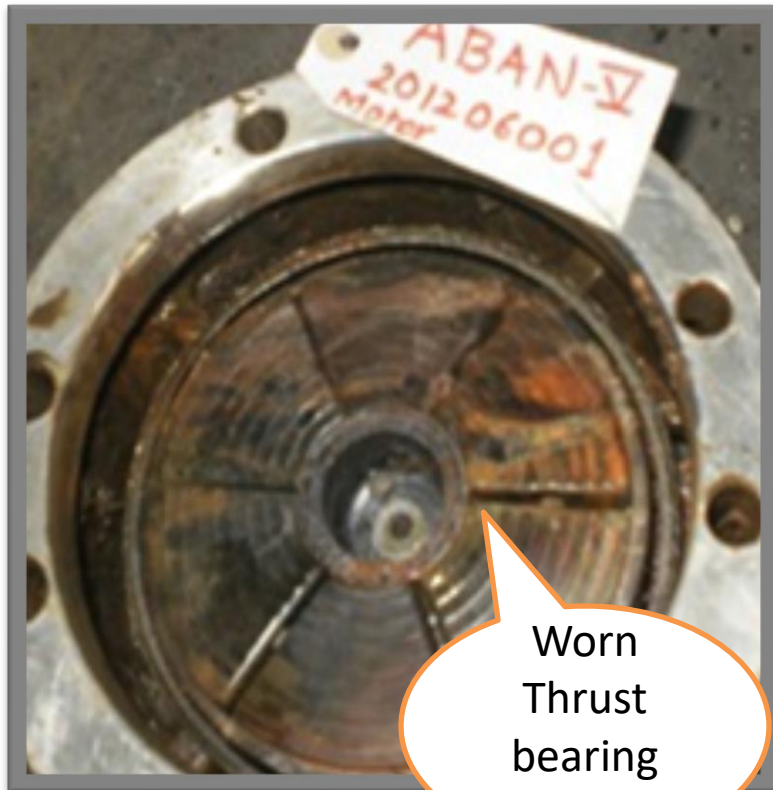
**BEFORE**

# THRUST BEARING HOUSING

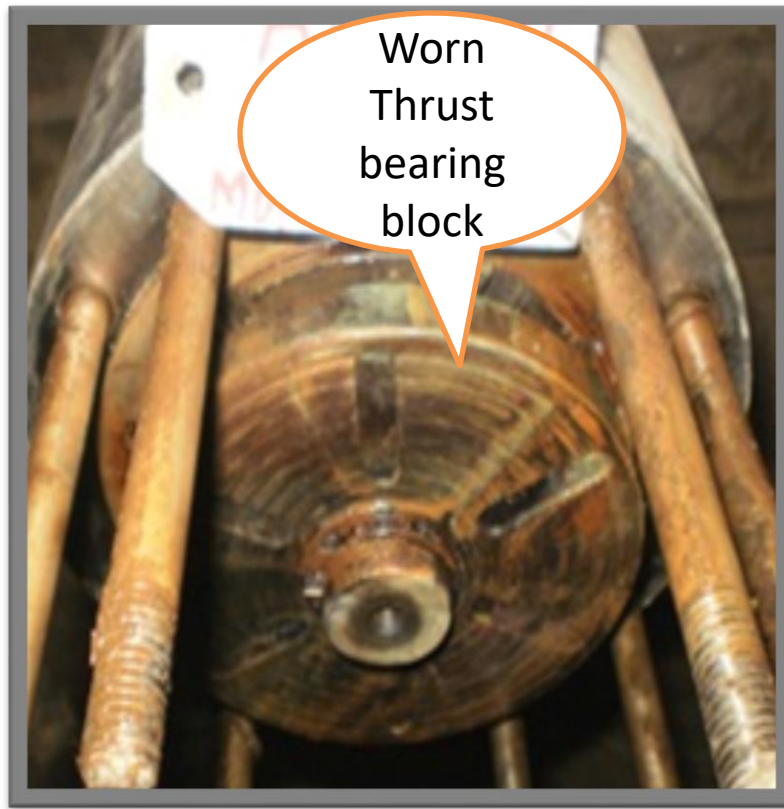
**BEFORE**

# THRUST BEARING BLOCK

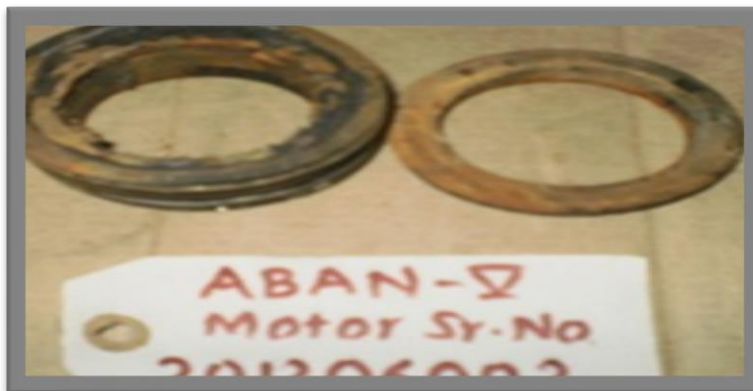
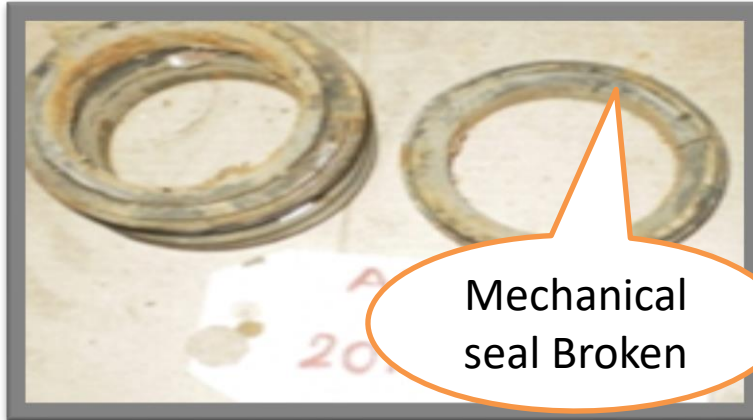
## BEFORE

# MECHANICAL SEAL

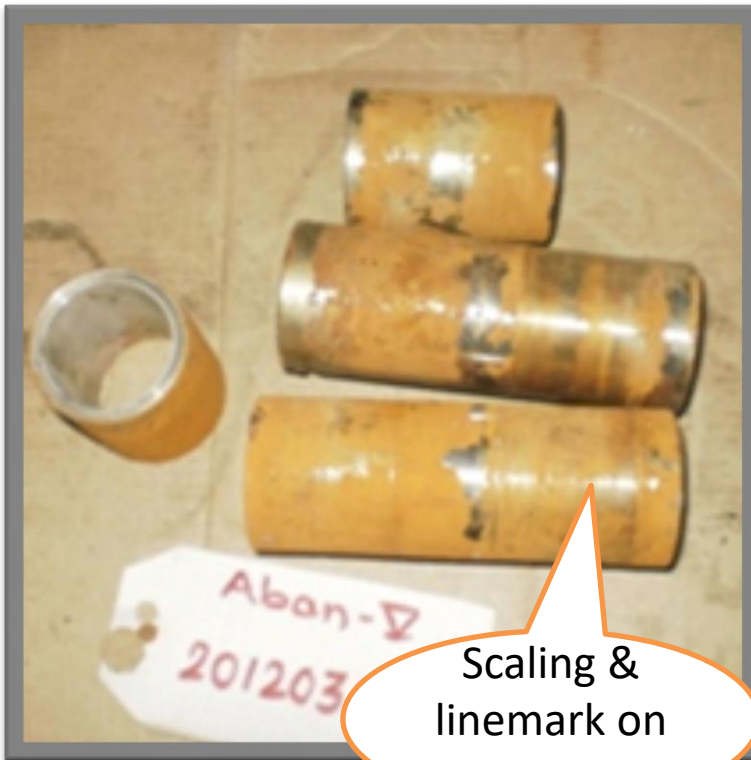
## BEFORE

# PUMP SLEEVES

Scaling &  
linemark on  
sleeve

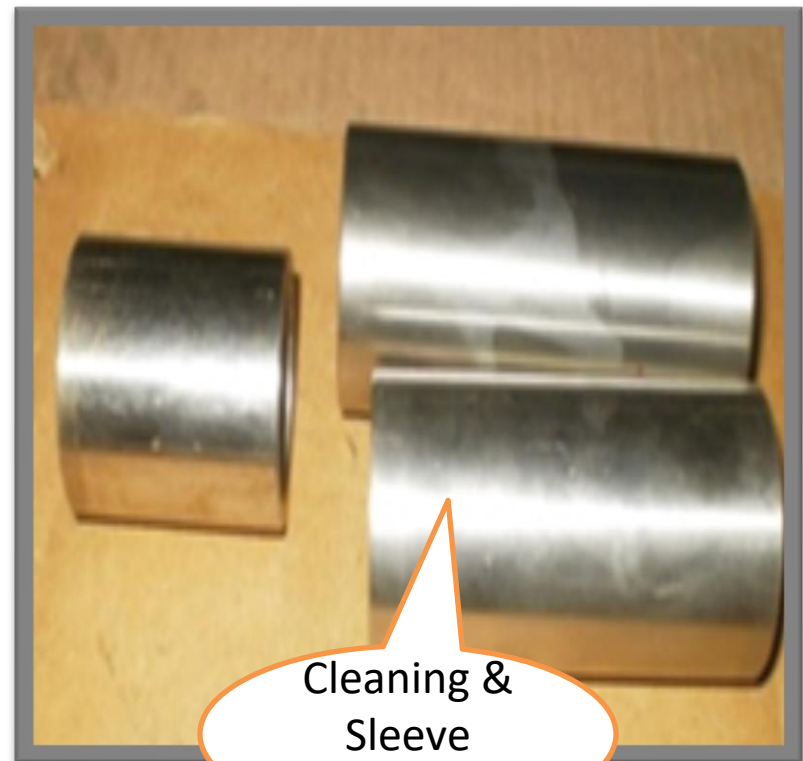
## AFTER

Cleaning &  
Sleeve  
Grinding

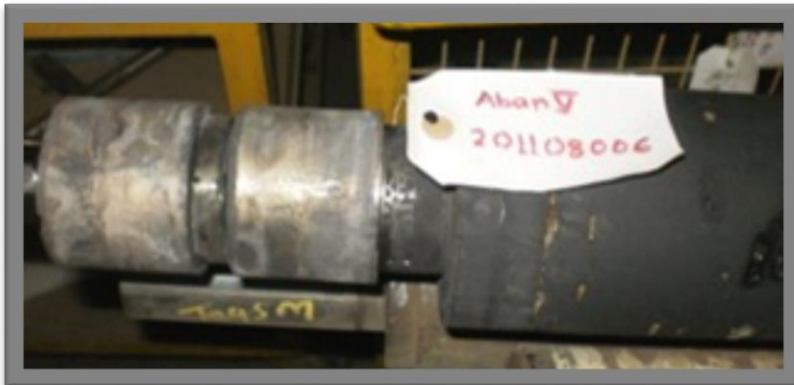
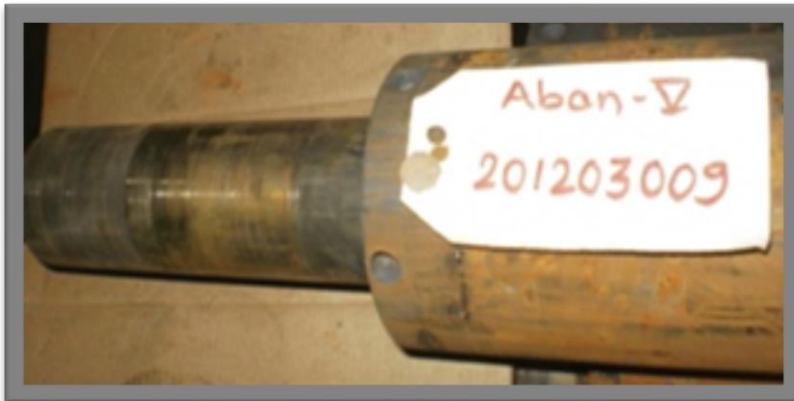
## BEFORE

# MOTOR ROTOR

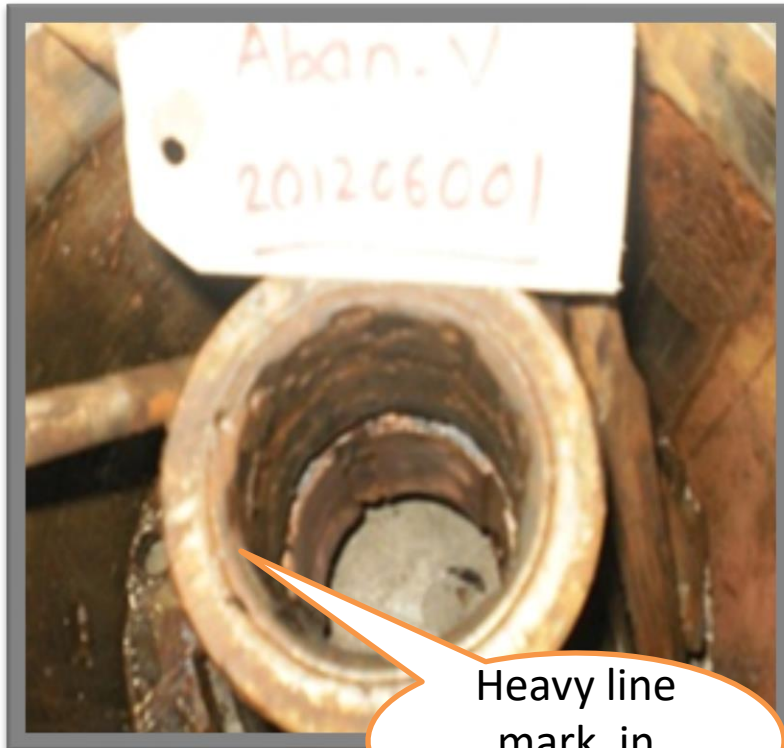
## BEFORE

# MOTOR BEARING

Heavy line  
mark in  
bearing

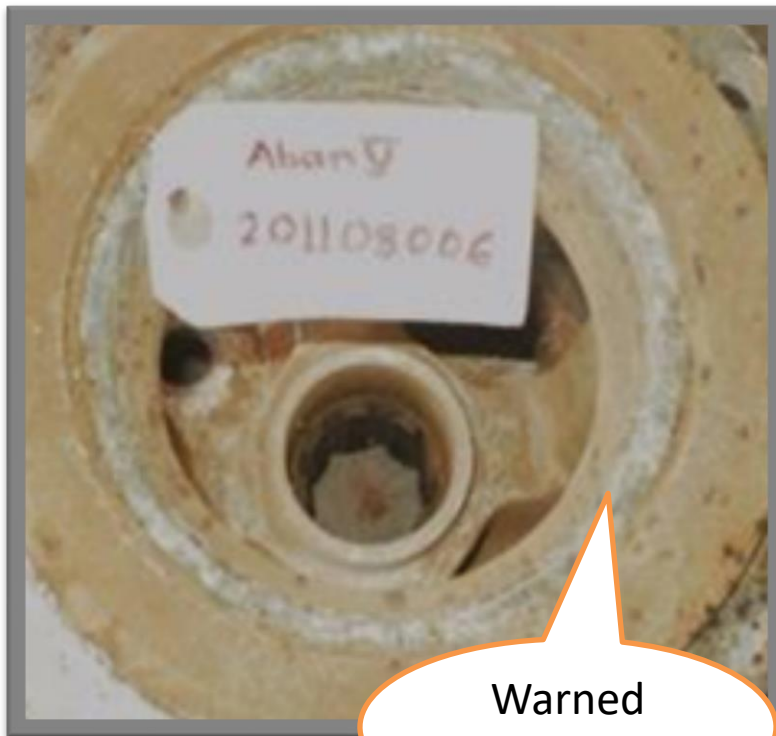
**BEFORE**

# PUMP NECK RING

Worn  
Neck ring

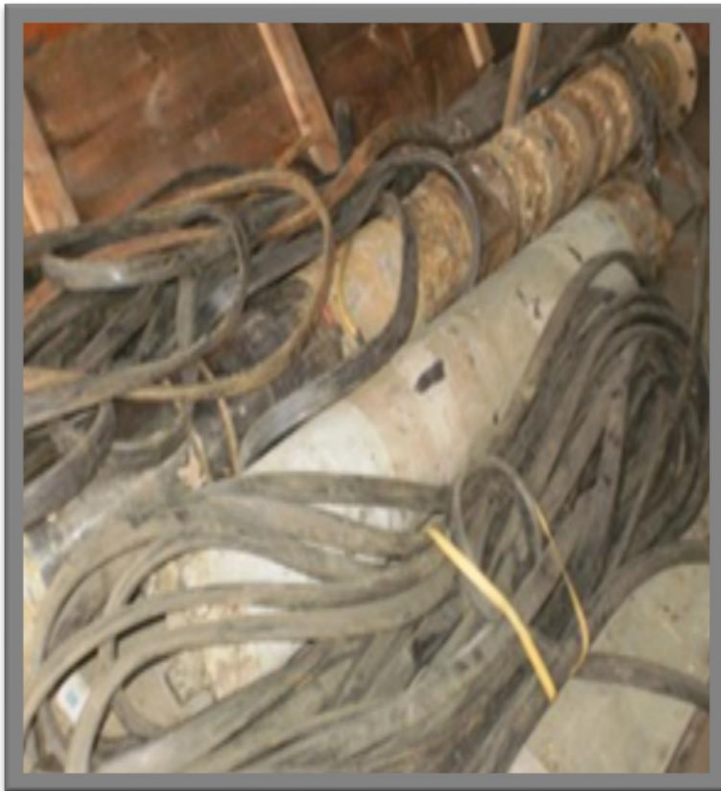
## RECEIVED STAGE

# PUMP SET

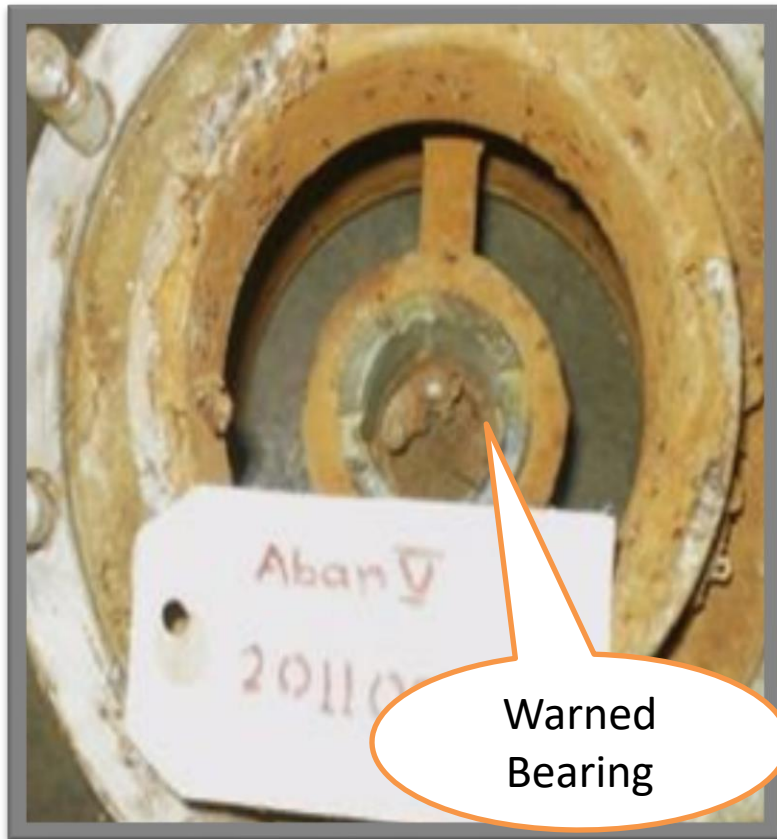
## BEFORE

# PUMP BUSH

Warned  
Bearing

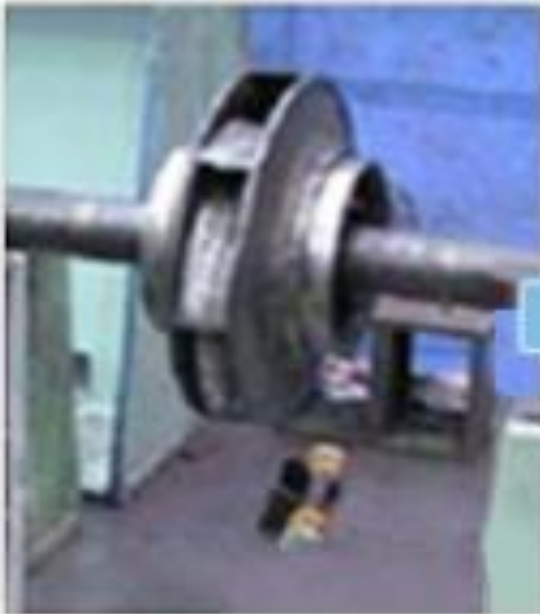
Before

# PUMP IMPELLER

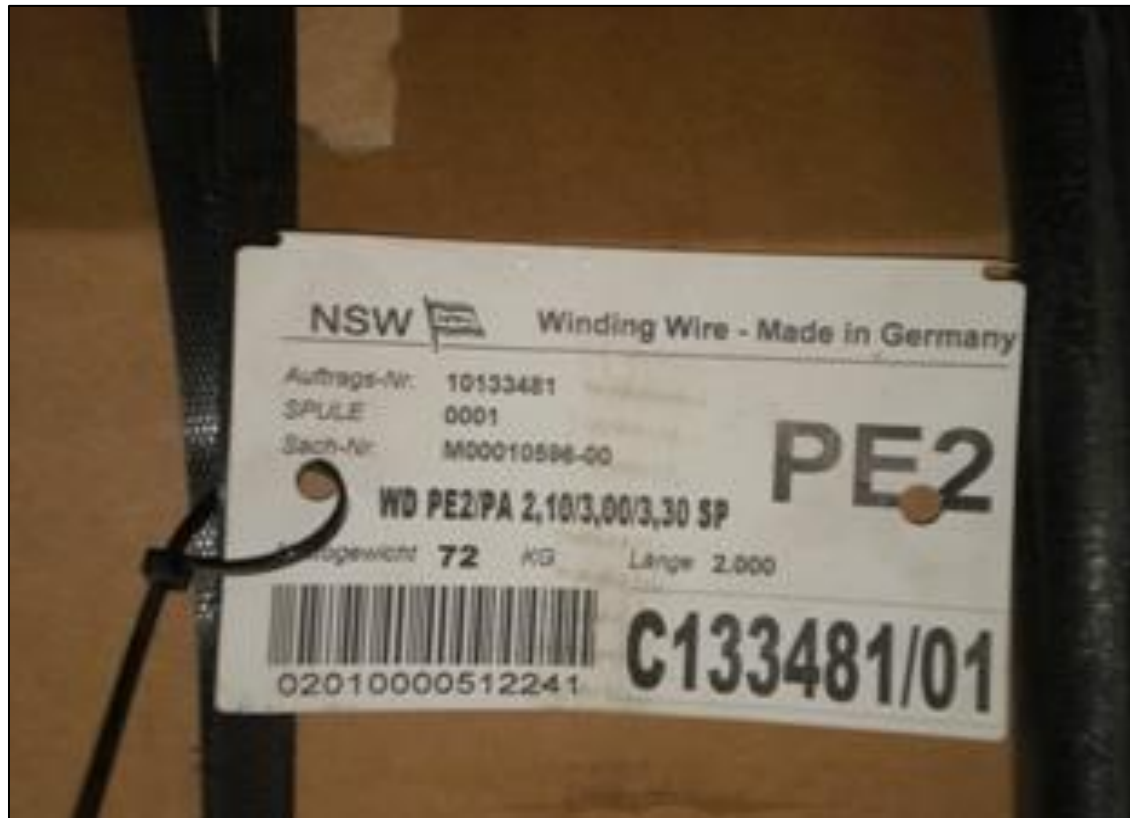
# WINDING WIRE

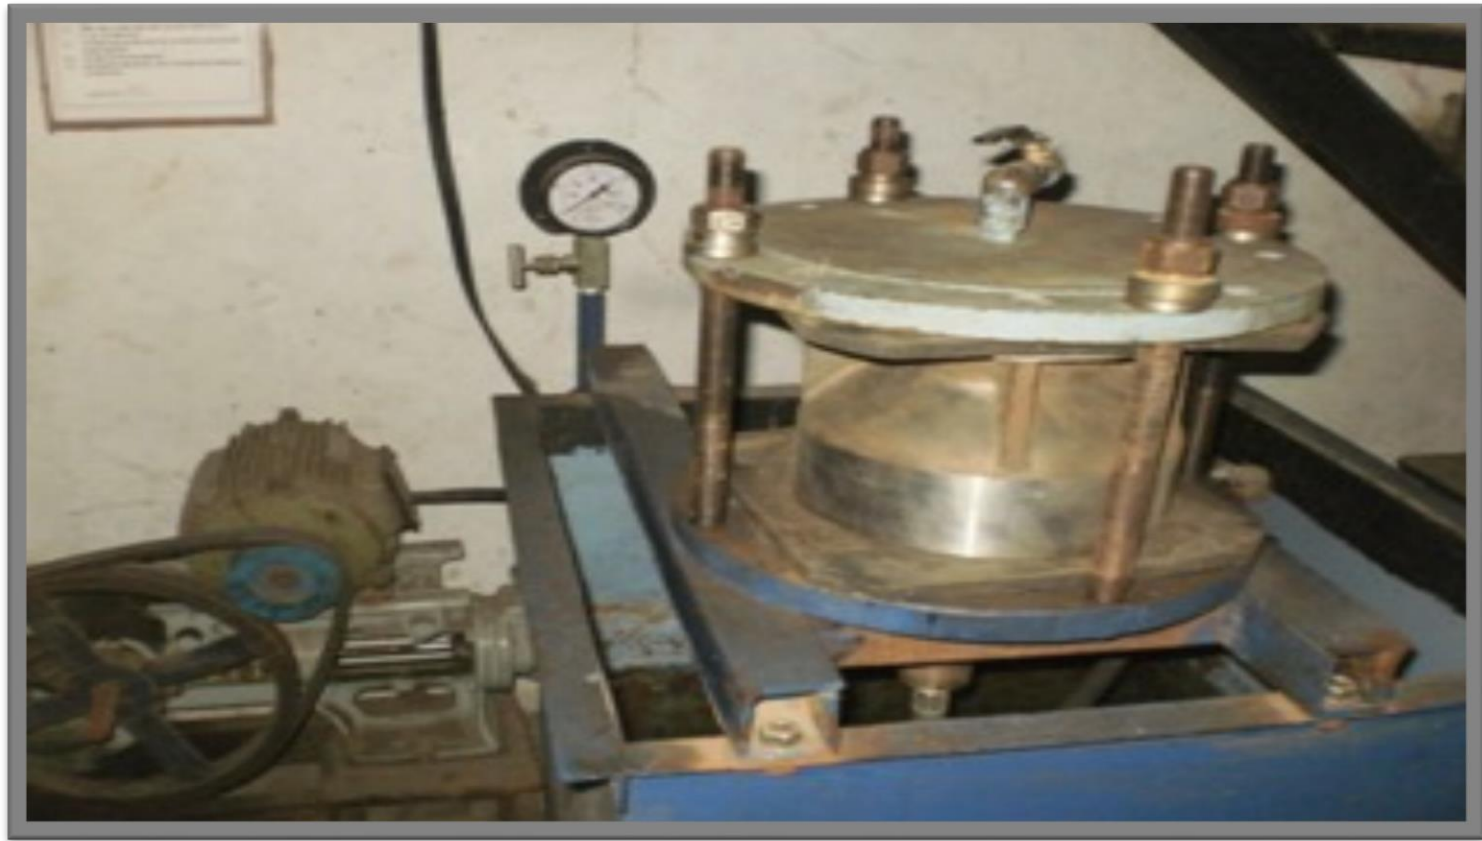
# HYDRO TESTING OF STAGE CASING

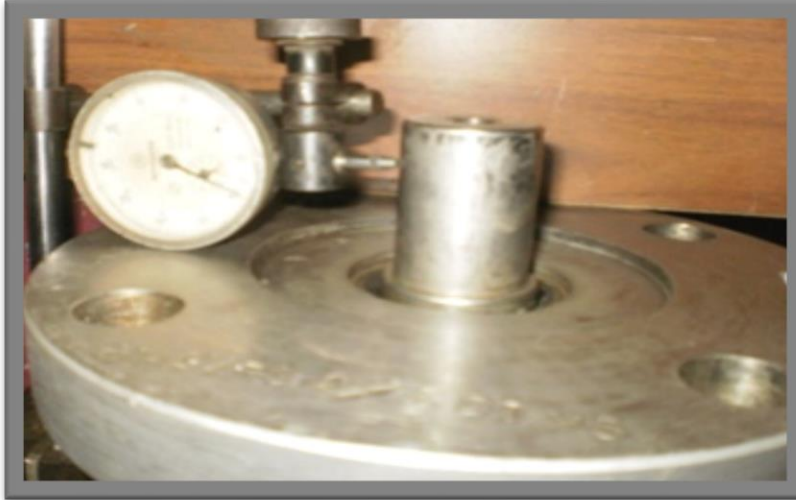
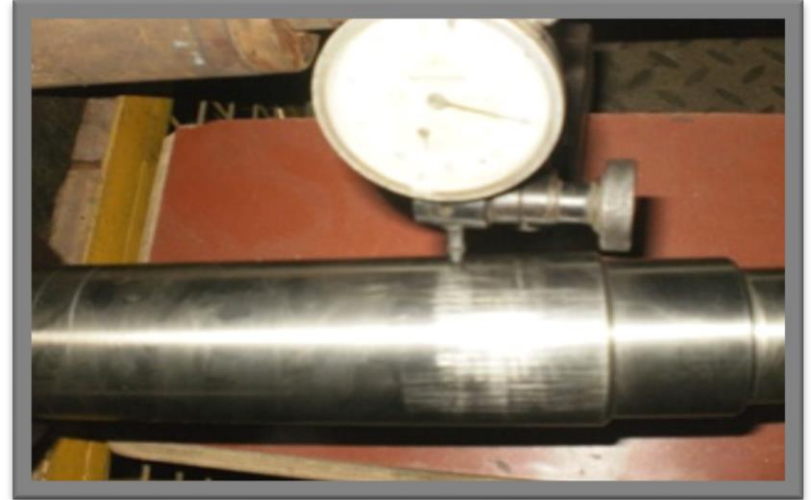
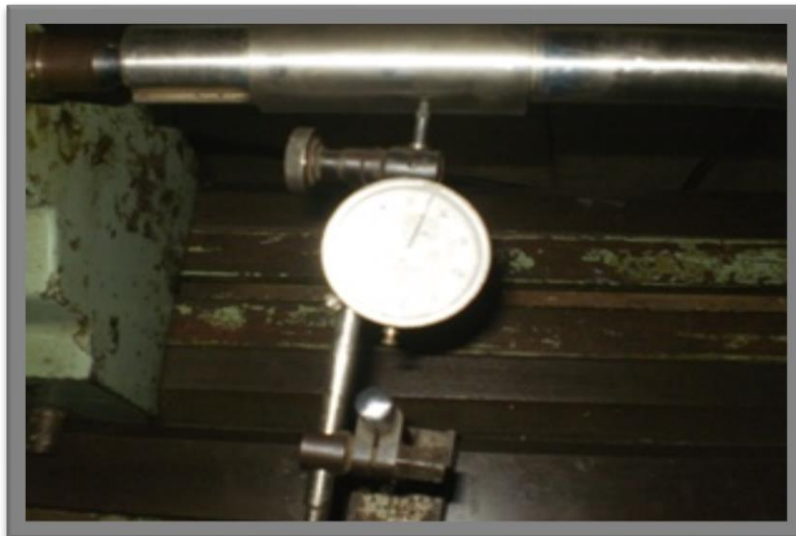
# QUALITY INSPECTION OF SHAFTS

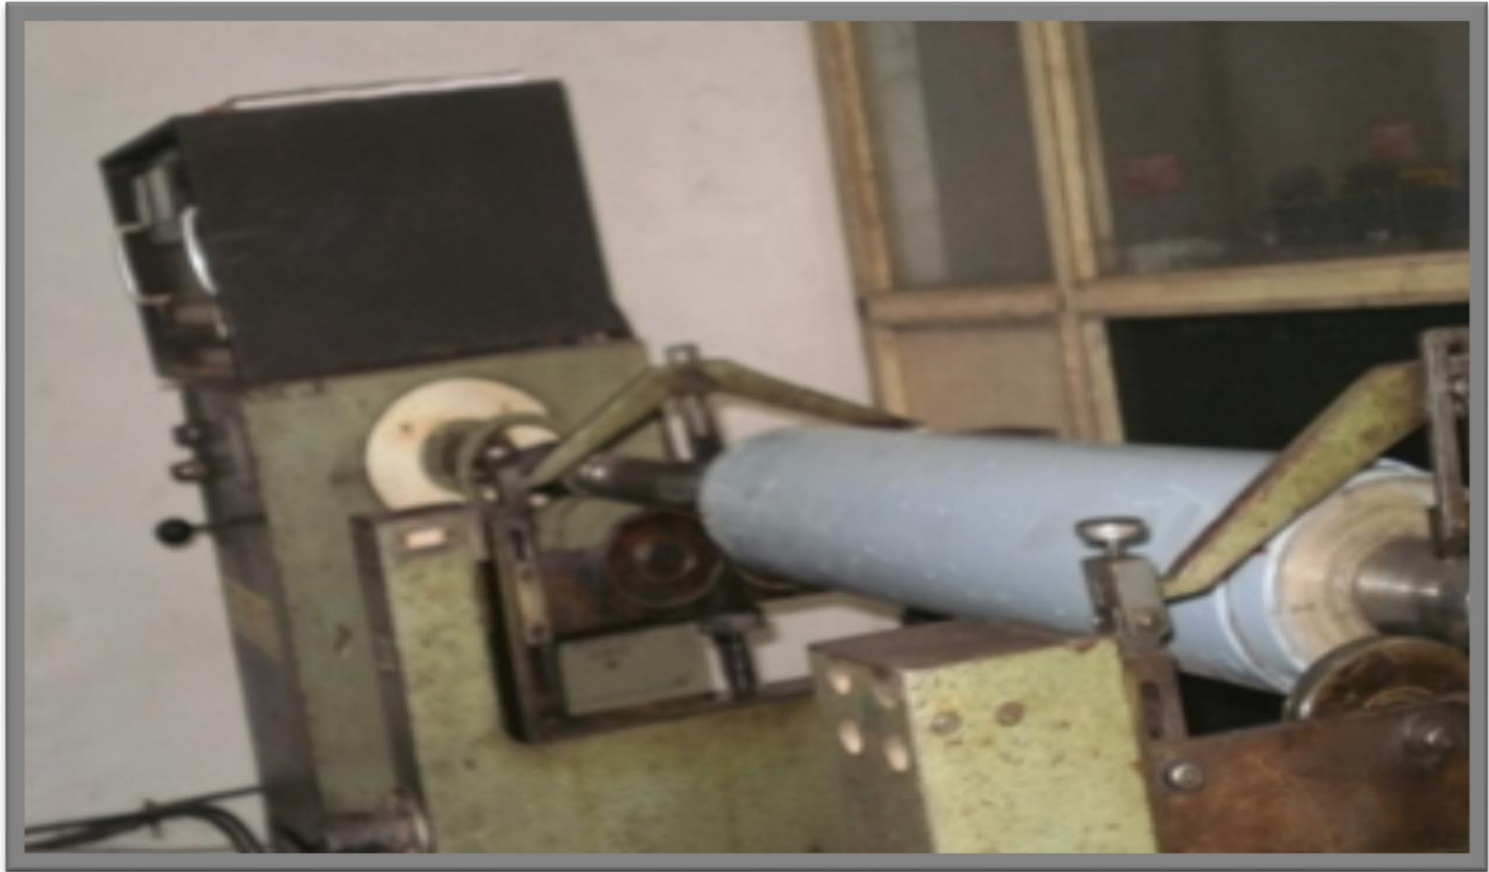
# ROTOR & PUMP SHAFT BALANCING

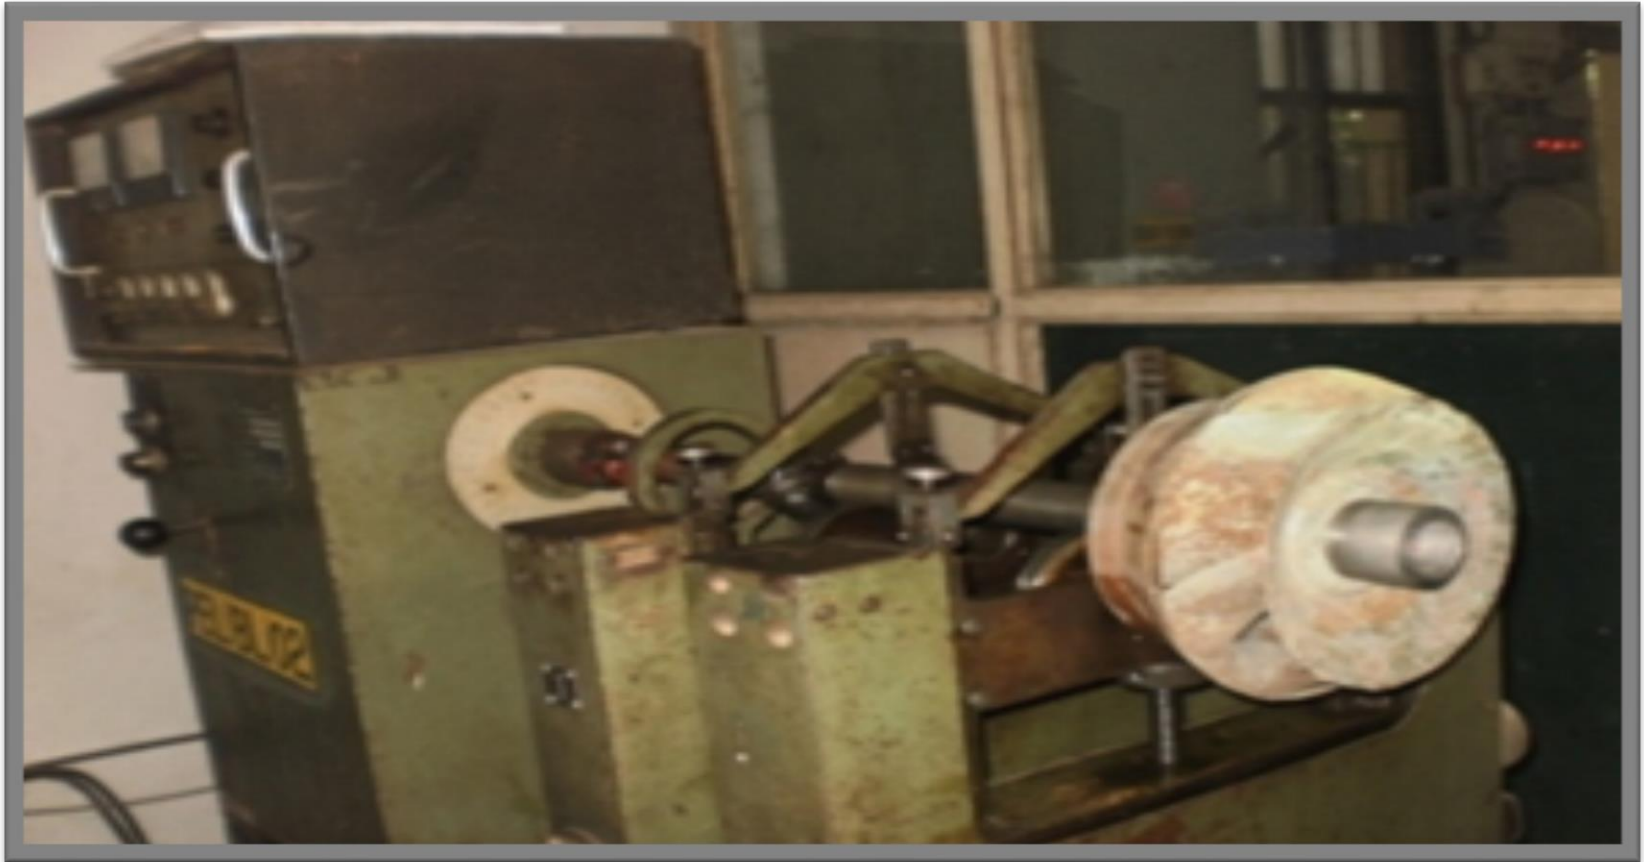
# IMPELLER BALANCING

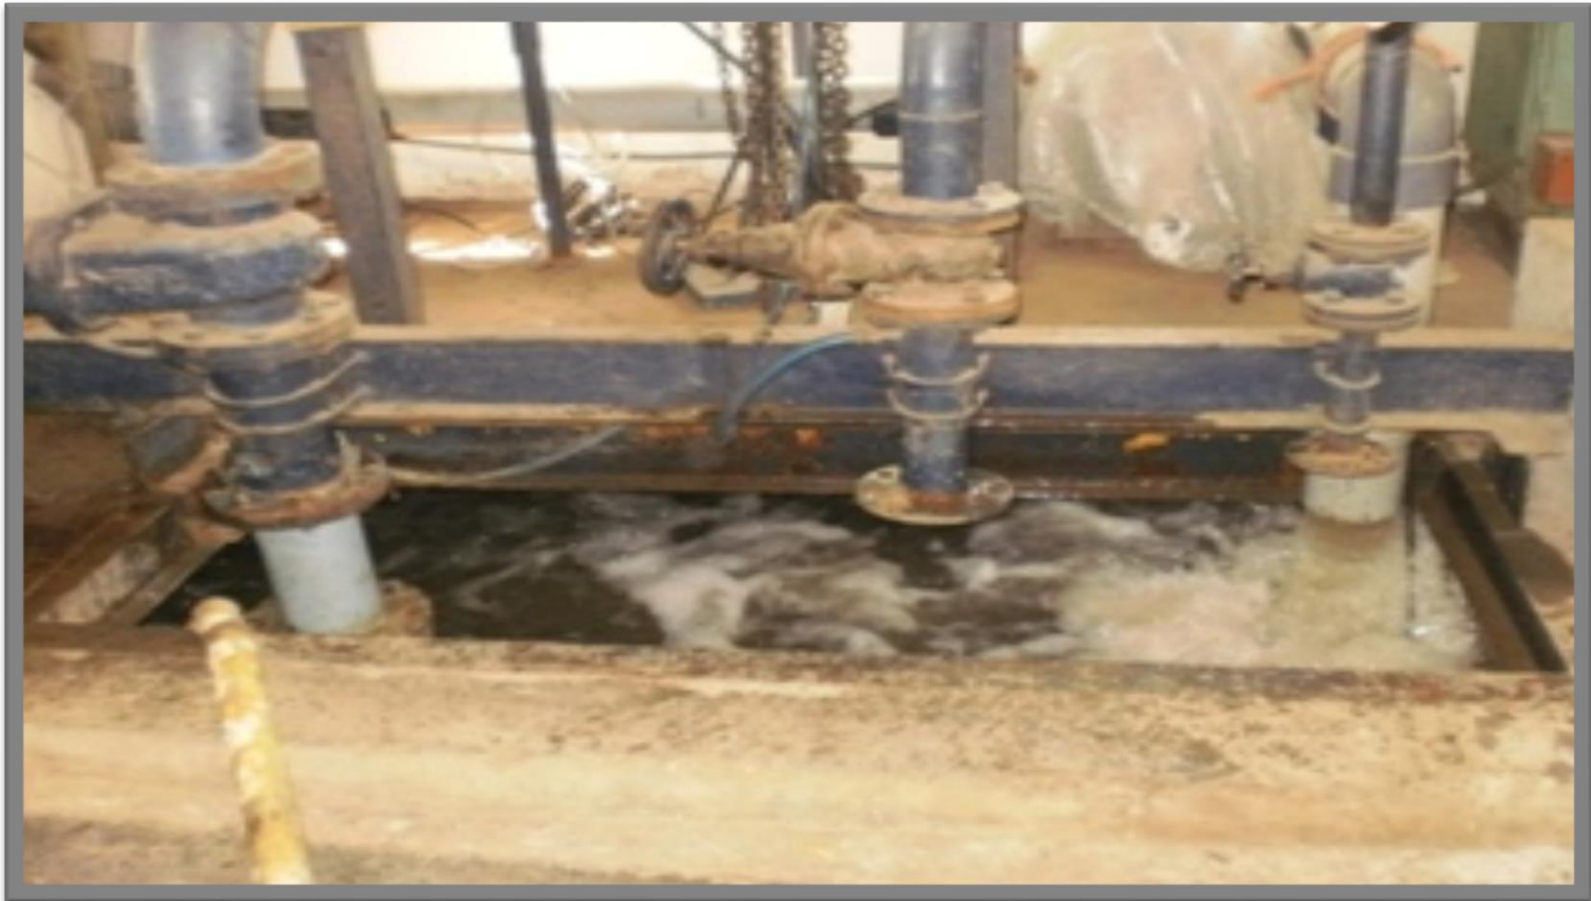
# PERFORMANCE TESTING

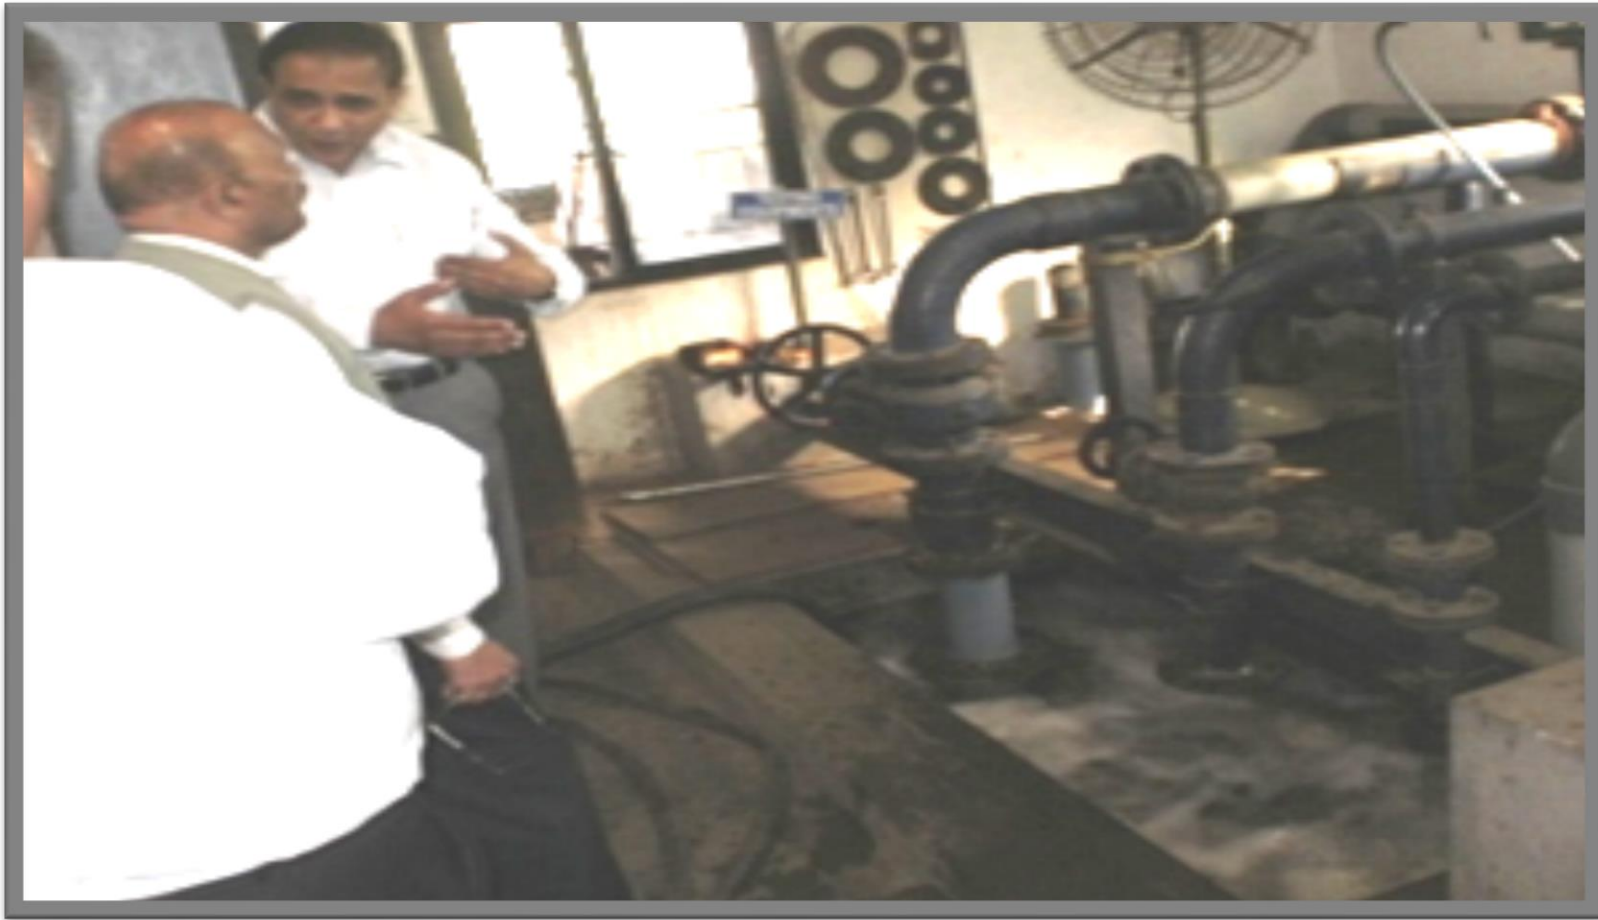
# PERFORMANCE TESTING
